Project Profile

Bearss Drain 2007 West Branch West Urban Drain, Section 78, Drainage Report

Client: Municipality of Port Colborne

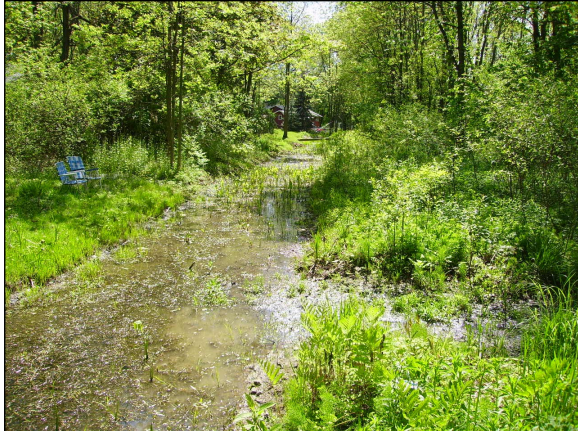
Drain Pre-Construction

During the design phase, there were a number of issues that had to be considered including Species at Risk and shallow bedrock. Landowners and Environmental Review Agencies were consulted during the design phase as we worked together to develop a solution acceptable to everyone.

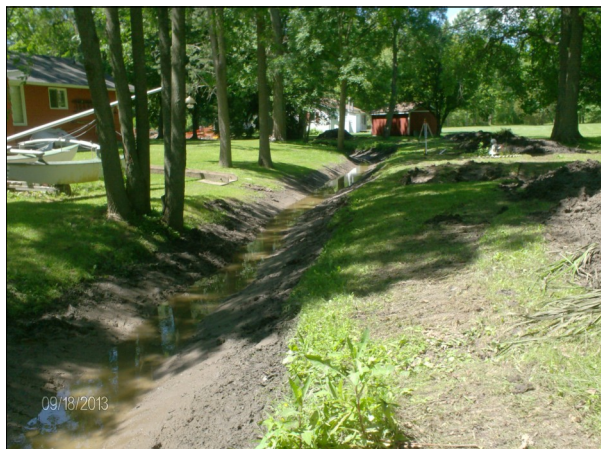
Drain Post-Construction

K. Smart Associates was retained by the Municipality of Port Colborne to prepare a Section 78 drainage report for the Bearss Drain. The Bearss Drain is a 85± hectare (210± acre) along the Lake Erie shoreline. The drain was constructed in the 1900's and there had been no maintenance activities since 1979.

An existing dune separates the lands on the north of the watershed from the Lake. Cottages are located along the dune and to the north of the dune. Prior to construction of the drain, the cottages to the north of the dune frequently flooded during the spring.

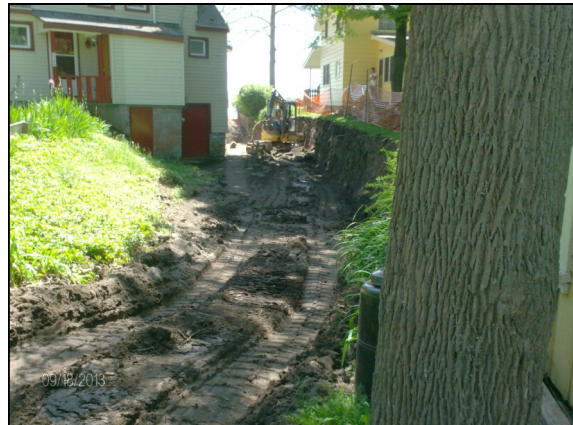
Working between two cottages

The construction included 163m of 900mm diameter concrete pipe, 308m of ditch clean-out, a stamped concrete outlet structure, 30m³ of bedrock and reinforcement of existing pipe in 35 working days.

Some of the difficulties that had to be overcome during construction included working around existing structures, watermains and a gasmain. Construction work often took place in tight areas, including between two cottages as shown in the photo above.
